Seismic performance of Bamboo housing– an overview

Jagadish Vengala¹, B. N. Mohanthy² and S. Raghunath³

^{1,2} **Indian Plywood Industries Research and Training Institute (IPIRTI)**, PB NO 2273, Tumkur road, yeshwanthpur, Bangalore – 560 022 INIDIA, www.ipirti.gov.in, email:

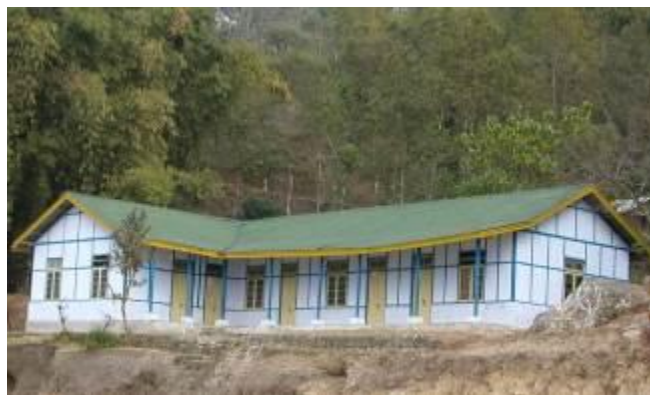
Plate 1: *Ikra* type housing (school building at Nandok, East Sikkim)(Kaushik et.al. 2006[2])

Traditional construction in Sikkim consists of mostly of typical bamboo houses, known locally as “Assam-type housing” and also known as ‘*Ikra*’ wherein a weed called *Ikra* is extensively used in the walls and the roof of the house. *Ikra* type of housing technology consists of stone masonry walls up to 1m above the plinth and the rest with wooden frame consisting of woven bamboo mat plastered with cement or mud mortar. A typical *Ikra* type housing is shown in Plate 1(Kaushik et.al, 2006 [2]).

The roof generally consists of light-weight materials such as **Galvanized Iron** (GI) sheets or thatch roof, supported by bamboo/wood trusses, which are laterally connected to the parallel walls. Steel angles and flats with bolts and nails are used to connect the *Ikra* wall to the masonry foundation wall.

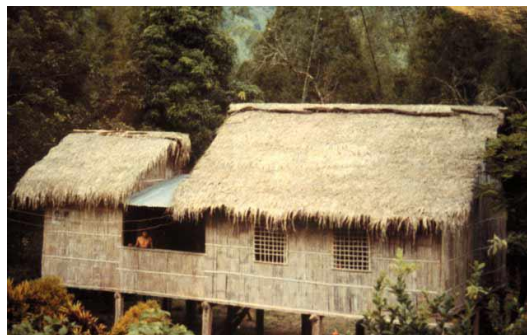
Plate 2: Bamboo house with *esterilla* in Ecuador (Gutierrez, 2004[5])

Rural construction of bamboo vernacular houses of Ecuador are made almost exclusively with vegetable material, using bamboo poles for most of the structure, *esterilla* for walls and floors, palm leaves or grass for the roof and, where flooding is frequent, timber poles to raise the floor from the ground. The *esterilla* of the walls is left uncovered. The '*esterilla*', is obtained by longitudinally cutting, flattening and removing the softer interior of the bamboo culms, which are then used as boards in walls and ceilings (Plate. 2).

The bamboo houses of South America are built almost exclusively with one particular species of bamboo, *Guadua angustifolia* Kunth. The *esterilla* of the walls is placed in double layers on both sides of the internal timber or bamboo poles, and daubed; originally, the daub was '*cagajón*', a mixture of mud and horse dung but later on, Portland cement replaced *cagajón*. The roof structure is usually made out of bamboo and it is covered with clay tiles. This construction technique is also known as *bahareque*, and has been extensively used in many countries of Latin America [5].

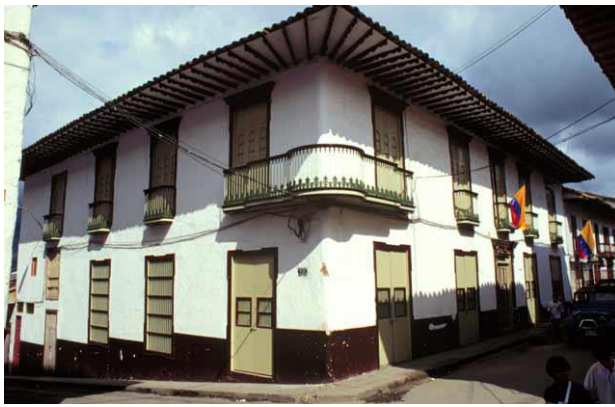
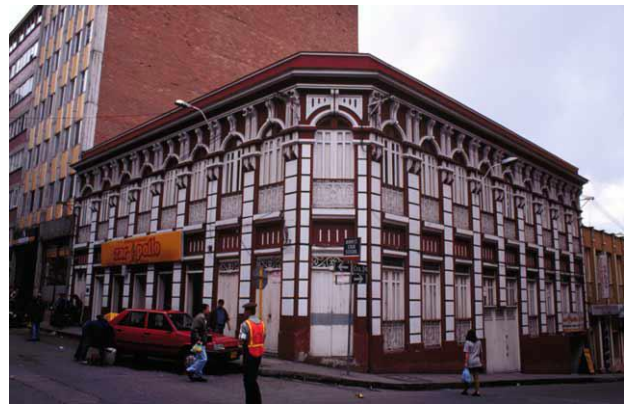
(a) Traditional *Bahareque* building

(b) Modern *Bahareque* building

Plate 3: Urban-traditional housing in Antigua Caldas (Gutierrez, 2004[5])

According to Robledo [6], “the houses where the timber is substituted with *Guadua* in the poles and diagonal bracing of the frame are more than a century old but are in excellent conditions (Plate 3 a).” This shows the capacity of the bamboo *Bahareque* to resist weathering as well as the moderate to strong earthquakes. In the early 20th century, to adapt to the trending construction practices bamboo *bahareque* buildings were plastered with cement mortar (Plate 3 b).

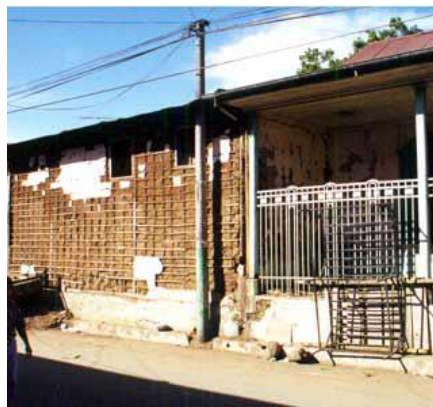
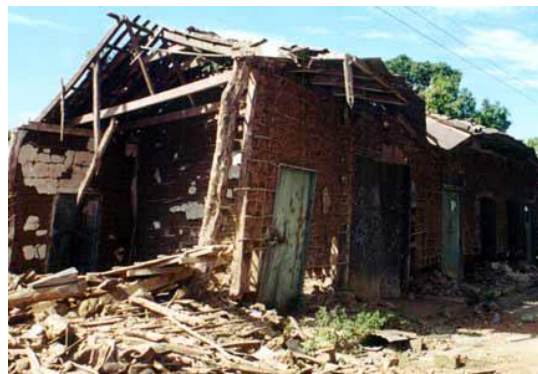
Plate 4 (a) Superficial damage to *bahareque* in Santiago de Maria 13 January 2001 earthquake (Lopez et. al., 2004[3])

Plate 4 (b) Collapse of *bahareque* dwelling in San Agustín (13 January 2001 earthquake) (Lopez et. al., 2004[3])

The failure of *bahareque* to provide adequate resistance and protection during earthquakes in El Salvador has been caused by a number of technical factors related both to the construction of these dwellings and to the lack of maintenance. Lopez et.al., [13] recommends that:

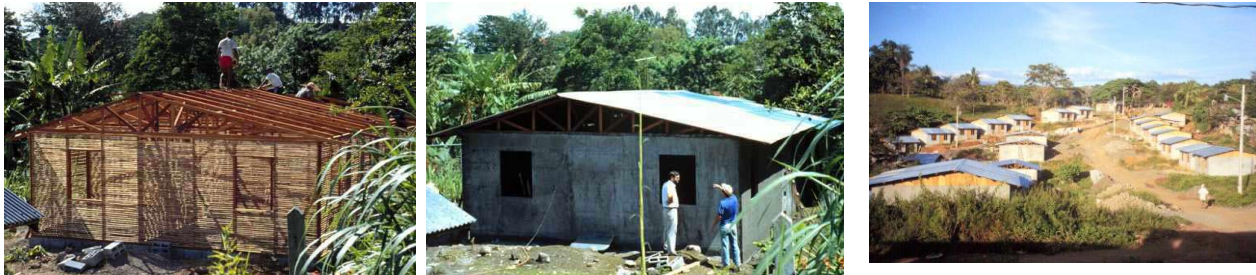
(a) Prefabricated panels (b) Plastered with cement mortar (c) A *bahareque* community

Plate 5: Prefabricated light *Bahareque* housing in Costa Rica (Gutierrez, 2004[5])

In Costa Rica, a timber-framed type of *bahareque* house was developed, with large (2.7 m x 2.4 m) but light prefabricated panels, consisting of small section (25mm x 50mm or 50mm x 50mm) timber frames with a single layer of canes, that were easily transported, manipulated, assembled on top of a continuous foundation and plastered afterwards with 5 cm of cement mortar, resulting in a very light but strong house type (Plate 5 a, b). In a 10- year period, more people came forward and built hundreds of such houses with this technology (Plate. 5 c) [14].

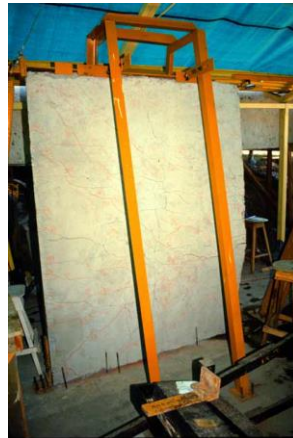
Plate 6: Monotonic load test on structural *bahareque* (Gutierrez, 2004[5])

In 1990, the University of Costa Rica constructed 13 engineered *Bahareque* wall panels and subjected them to monotonic in-plane load (Plate 6) (Mendoza & Villalobos, 1990[15]). The panels consisted of a timber frame clad in *esterilla* and finally rendered with cement mortar. These tests demonstrated that the load capacity of the wall panels is considerably greater than the seismic load demand from the Costa Rican code.

Failure occurred by either buckling of the leading stud in compression or a tensile failure of the rear stud. The cement render did not tend to spall, regardless of the use of chicken mesh. Based on the tests conducted, a group of 30 *Bahareque* houses had been built at the site of the epicenter. During the 1991, Limon, Costa Rica earthquake (M_L 7.5), all of them resisted the strong shaking without the slightest damage (Gutiérrez, Handley [16], [17]), even in sites with widespread liquefaction (Plate 7).

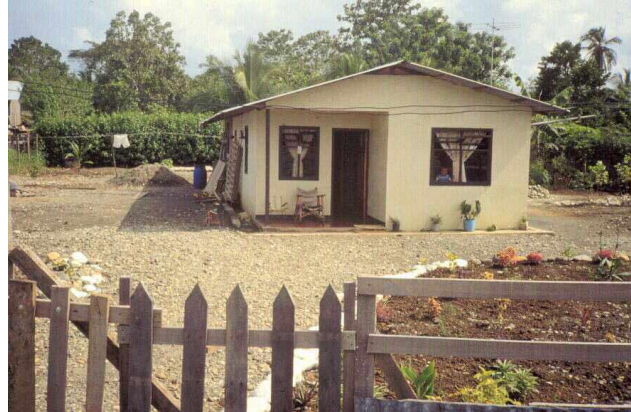
Plate 7: Undamaged *Bahareque* house after the 1991 Costa Rica earthquake (Gutierrez, 2004[5])

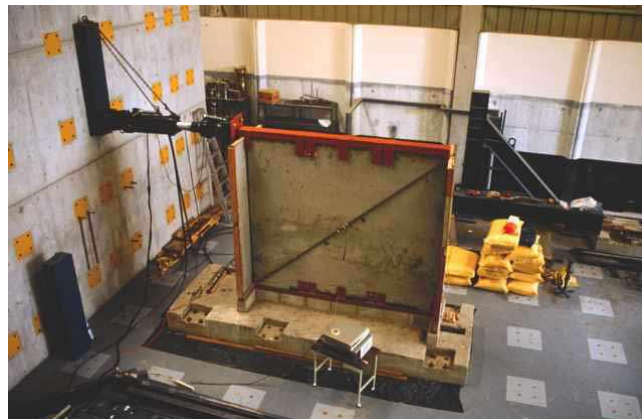
Plate 8: Cyclic load test on structural *Bahareque*, in Costa Rica
(Gonzalez and Gutierrez, 2003[18])

In 2004, a series of cyclic tests were conducted on similar specimens (Plate 8). This research confirmed the original test results and suggested that the walls had some ductility under cyclic loading. (Gonzalez and Gutierrez, 2003[18])

Based on these tests, it is considered that “these wall panels tend to work compositely, with the cement render taking most of the load as a diagonal compression strut, the wall matrix controlling cracking and out-of-plane buckling and the timber studs taking the vertical tension induced by the diagonal strut.”

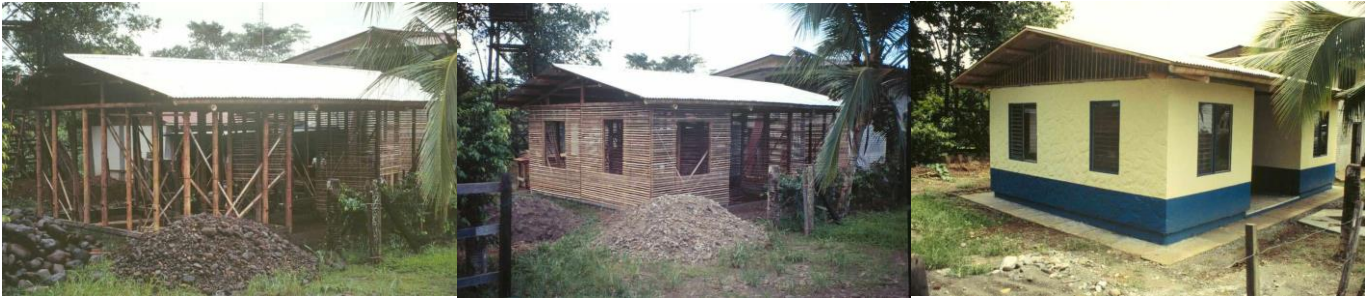
(a) Bamboo structure

(b) Bamboo curtains

(c) Finished house

Plate 9: Bamboo *bahareque* house with prefabricated poles and curtains (Gutierrez, 2004[5])

The resulting design effectively eliminated the panels and substituted them with individual bamboo posts placed on top of similar diameter prefabricated concrete cylinders that served as the foundation and raised the bamboo from the ground for the required humidity protection.

The bamboo poles were connected at the top by horizontal bamboo beams, providing the structural integrity. Prefabricated bamboo curtains, made out of laths and flexible wire, were hung down

from the beams to the concrete base and joined to the poles. Finally, the walls were plastered with cement mortar. Plate 9 shows the bamboo *bahareque* house with prefabricated poles and curtains.

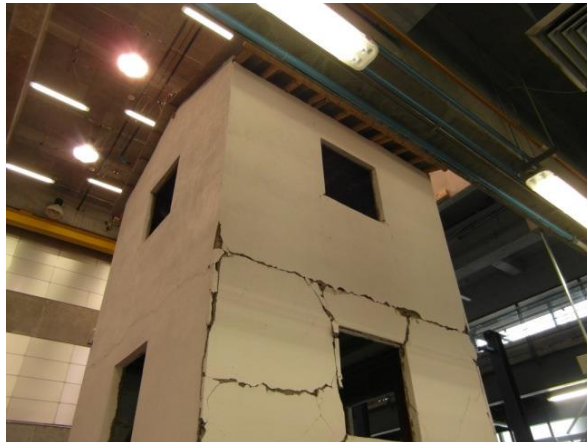
Plate 10: Unidirectional shake table test on two storey house at the University of the Andes, Colombia (Arup & Imperial College, 2013[21])

This interest spurred the Colombian Earthquake Engineering Association to conduct research into engineered *Bahareque*, which included a series of racking tests on wall panels using *Esterilla*, chicken mesh and cement render and the results were similar to those obtained in Costa Rica. Following this, the construction manual for seismically-resistant housing using mortared *bahareque* was published (Prieto et. al., 2002[20]), per which some of the new bamboo houses were designed. Even shake table tests were conducted on full-scale, two-storey braced engineered bamboo house and the design complied with the Colombian seismic design code (Plate 10) (Arup and Imperial College, 2013[21]).

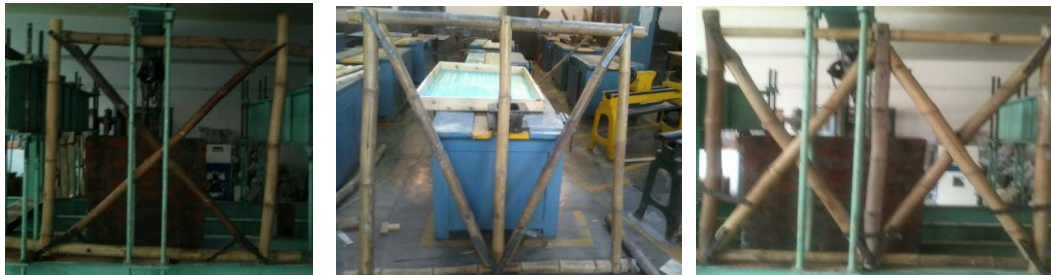
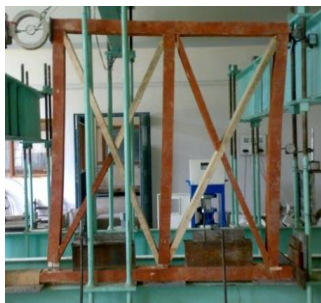
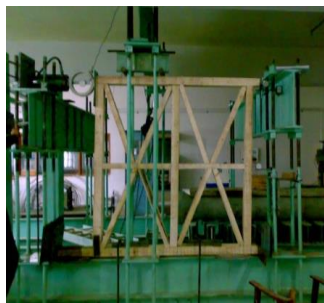
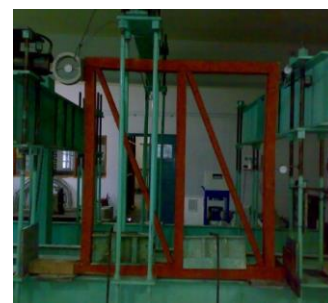
Plate 11 Typical view of six types of test frames (Aaqib Mir et. al., [22])

The Dhajji Dewari style of construction emerged as a time-tested earthquake resistant technique, indigenously developed through lessons learnt from repeated earthquake disasters over several generations, both in the rural and urban setting of Kashmir which falls under seismic zone V. The work by Aaqib Mir et.al., [22] focused on the revival of the traditional Dhajji Dewari earthquake resistant technique by replacing the timber with bamboo thus making it cost effective and also increasing its strength. Thus, replacing timber with bamboo in Dhajji Dewari is hoped to change the mindset of people who are no longer opting for this technique due to the non availability of timber and its spiraling cost. **Six types of frames were tested (Plate 11). Configurations 1 to 3 are bamboo frames with single and double bracing. Configurations 4 to 6 are the timber frames with similar arrangement to that of bamboo frames. The loading system consists of proving ring at the top edge of the frames which records the load applied from a hydraulic jack. Deflections were measured using a dial gauge located at the mid height and top height of the frame.** Based on the test results on 6 types of frames (Plate 11) authors could conclude that the joints are the critical locations in these types of traditional constructions. Double bracings increase the strength when compared to single bracings and also strengthening of joints by iron straps increases the load carrying capacity. The lateral load resisting capacity of bamboo frame is ranges from one-and-a-half to three times when compared to that of timber frame. The choice of configuration highly affects the performance of Dhajji in earthquakes. So replacing timber with bamboo is useful both in terms of cost as well as strength in Dhajji Dewari style of construction.

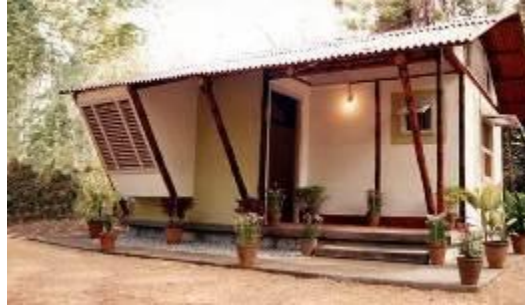
Plate 12: Demonstration house built by using IPIRTI-TRADA technology at IPIRTI, Bangalore; source: author

In India, although bamboo is widely used in some regions, it must be emphasized that its use has been primary as a semi-load bearing element or as infill material in timber framed houses. It is in this context that the bamboo housing technology developed at IPIRTI in collaboration with TRADA, U.K. which demonstrated the engineering application of bamboo in housing. Plate 12 shows the demonstration houses at IPIRTI, Bangalore.

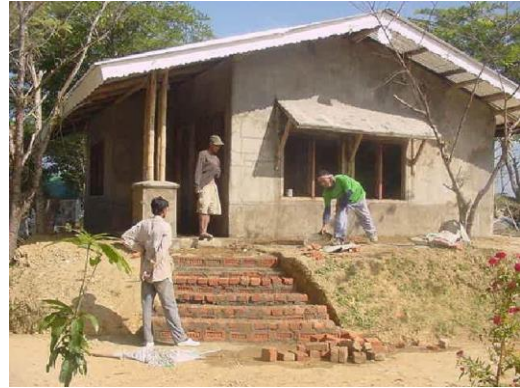
Plate 13: Demonstration house at Mizoram, Latin American earthquake resistant housing technology

Since India has large areas falling in the zones of high seismicity, bamboo can play a vital role in appropriate housing and construction owing to its suitability and availability. Bamboo possesses excellent strength properties, especially tensile strength and is much more flexible than hard wood and concrete materials. For this purpose, it is necessary to develop technological packages, which can be easily adopted for mass housing in such areas. Typical Assam house (Figure 3) has wooden frame with infill plastered bamboo lath and has been found to be effective in resisting earthquakes. A demonstration house (Plate 1.10) was constructed at Mizoram using Latin American earthquake resistant bamboo housing technology [24].

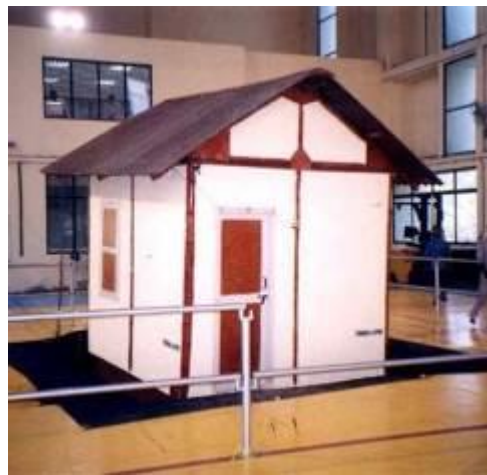
Plate 14: Bamboo house under shake table testing at CPRI, Bangalore [1]

The bamboo house of 2.7m x 2.7m was tested on shaking table (Plate 14). The mass of the house was 2636kg. A seismic simulation of 30 seconds was carried out on the bamboo house for a design spectrum of zone IV and zone V classification as per IS-1893, 2002 [25].

To test the fatigue strength of the bamboo house zone V design spectrum was repeated for five times. Even Kobe earthquake data was also simulated for the same house. After the test program, the structure did not exhibit any cracks or damage in any part of the building [1]. The testing program needed a sophisticated facility and the perhaps the costs constrained the testing of more models.

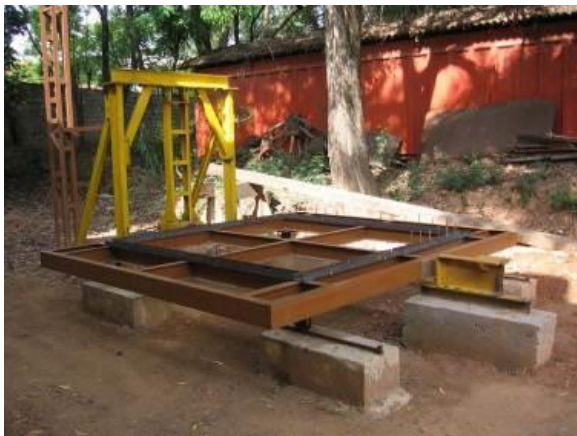
Plate 15: Shock table at IPIRTI

shock table measured 3.05 m x 3.66 m and weighed 6400 N. The grooved wheels were supported on rails made of inverted T-section. These two rails were anchored to the rigid concrete foundation and the base concrete. The table could be set into motion through pendulum impacts on one side and rigid rebound beam on the opposite side of the table facilitated the reverse motion. The length of suspended pendulum is 1.6m from the centre of the hinge to the centre of the hammer weighing 4000 N. **Figure 4 shows the layout of the shock table.** Plate 15 shows the shock table facility at IPIRTI, Bangalore.

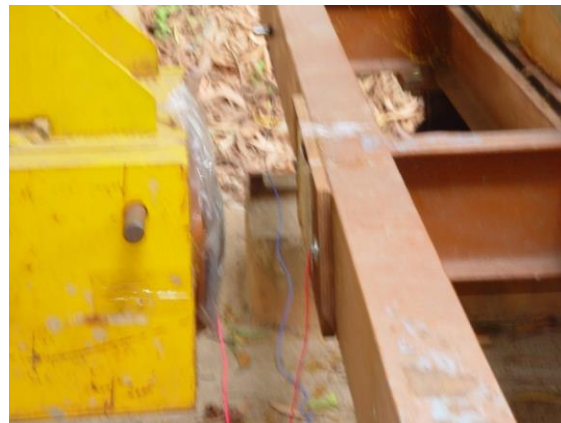
Plate 16: Arrangement at the point of contact for the measurement of contact duration

The shock table can be subjected to a series of controlled base shocks using a pendulum impacting device for different angle of releases starting from 5 degrees to 50 degrees at an interval of 5 degrees. The response of the shock table can be observed and monitored using accelerometers mounted at various locations which are in turn connected to a high speed data acquiring system. Plate 16 shows the arrangement at the point of contact for the measurement of contact duration.

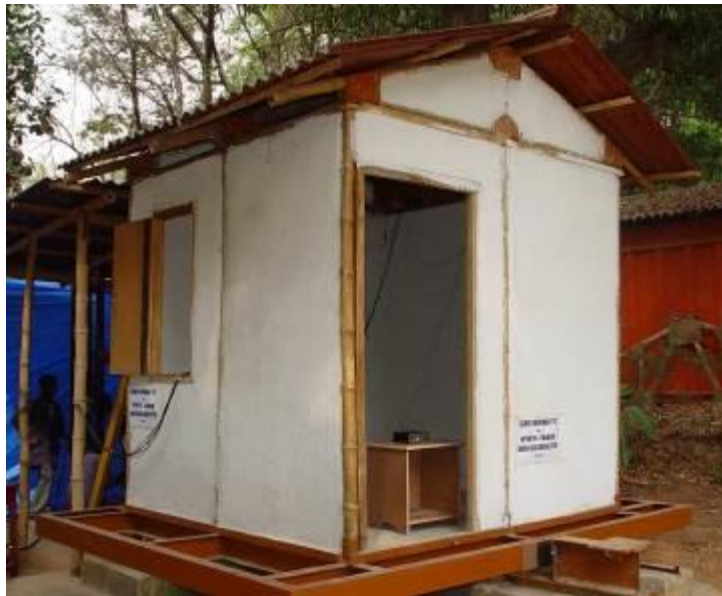
Plate 17: Bamboo house model during testing

The test program consisted of 15 shocks given to the shock table. Various parameters of the shocks are presented in Table 1. The performance of the 2.44m x 2.44m full-scale IPIRTI-TRADA building model is described below. The total cumulative energy imparted after all the tests was 13236 N-m. Figure 5 gives the test setup and Plate 17 shows the bamboo house during testing.

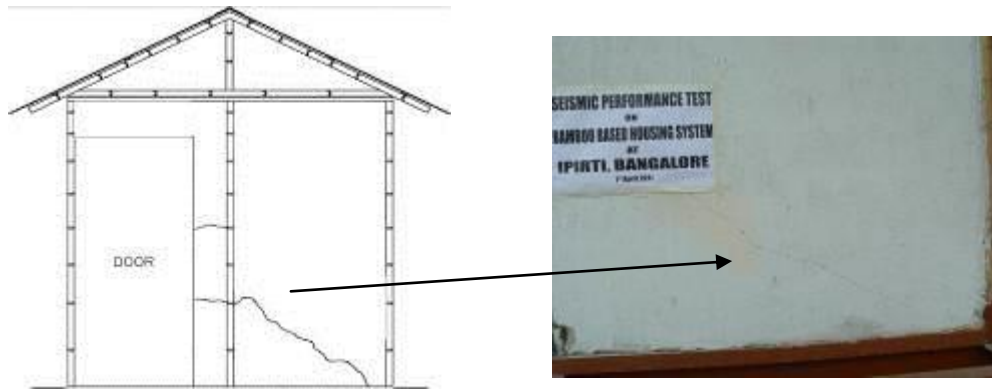
Figure 6(a): Front side crack pattern of Bamboo house

Figure 6 (b): Outside crack pattern of bamboo house on pendulum side

Figure 6(c): Outside crack pattern of side wall

Figure 6: Crack patterns observed for model-1

- v) Shock 13, 14 & 15: Pendulum angle 40° : The table was subjected to three shocks with an angle of 40° . Cracks were observed on both inside and outside portions of the house as mentioned in Figure 6(a) to (c). Only outside portion cracks were visible as shown in Figure 6.

After the last set of three shocks with an angle of 40° , the cracked portions were observed even in the inside portion of the house model. However the cracks were clearly visible only on the outside portion of the walls. After the test program, the prototype resisted the shocks and showed no signs of falling apart. Thus it can be stated that the model has met the objectives of resisting major to moderate levels of dynamic forces with minimal damage levels. Thus it could be stated that the model had met the objectives of resisting moderate levels of dynamic forces with minimal damage levels. The author is involved in carrying out the further experiments on this.
